FINAL REPORT

ACCIDENT

**AS350 B3 reg. marks I-EDIC and Jodel D.140E reg. marks F-PMGV,
at Rutor glacier, La Thuile (AO),
January 25th 2019**

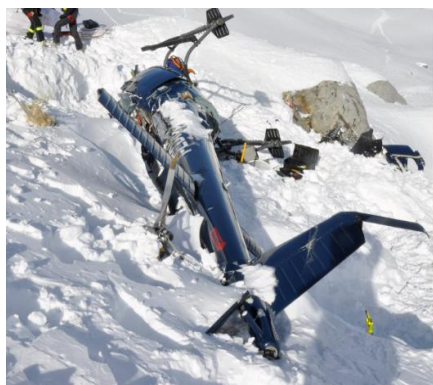
The wreckage of the helicopter was upside down and nose down, the pilot and passenger cabins completely missing, the front part of the fuselage severely damaged, the tail beam disconnected from the fuselage.

Photo 8: I-EDIC, rear view.

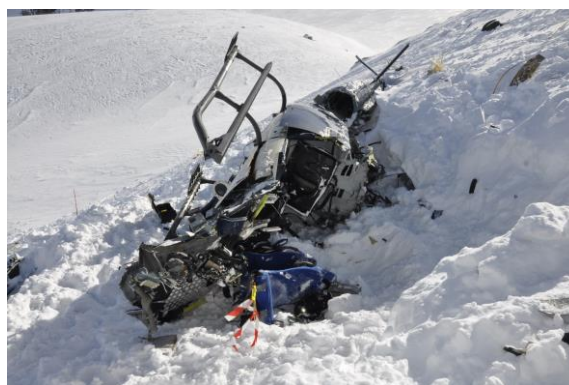
Photo 9: I-EDIC, front view.

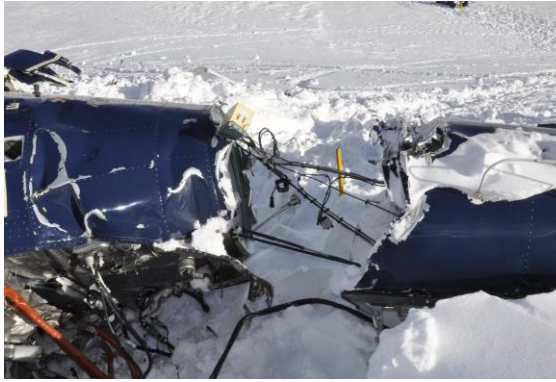
Photo 10: I-EDIC, tail beam disconnected from the fuselage.

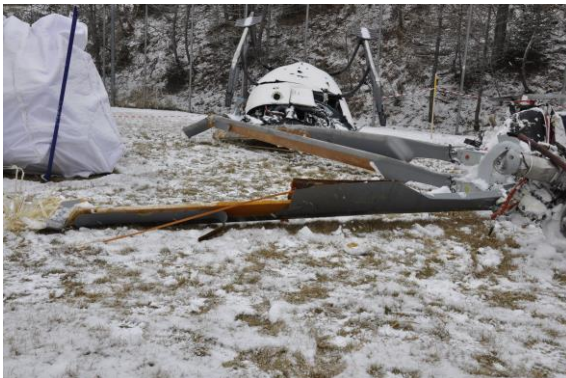
The main rotor and its blades had sunk into the snow. Once brought to the surface and transported down the valley, it was found out that the three blades were still connected to the rotor head and were heavily damaged, with clear signs of impact against a red painted surface.

Photo 11: main rotor blade.

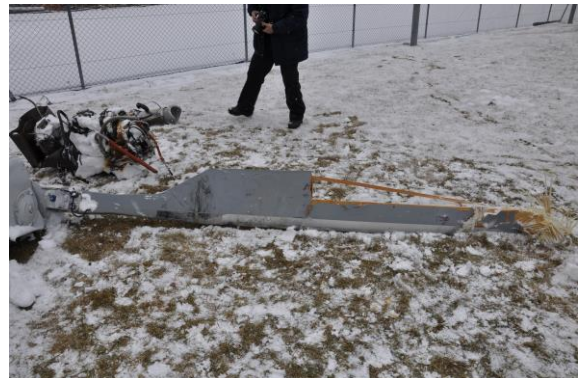
The blades were deformed due to impact against a metal object. One of the blades outer section, approximately 1.20 m in length, was missing.

Photo 12: main rotor blade with outer section missing.

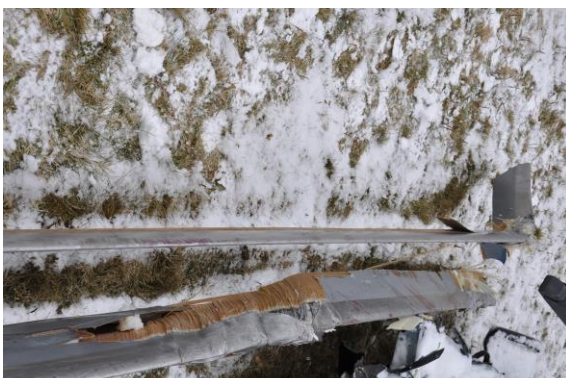
Photo 13: signs of red paint on main rotor blade.

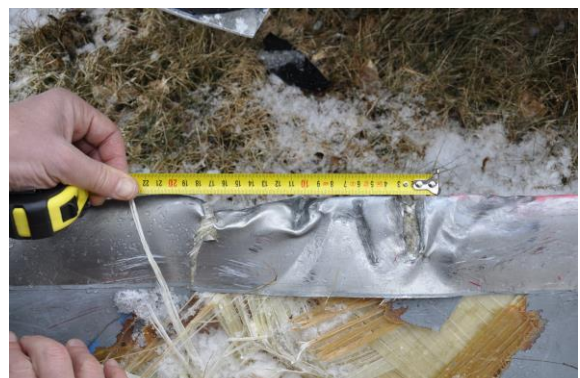
Photo 14: main rotor blade deformations due to impact against metallic parts.

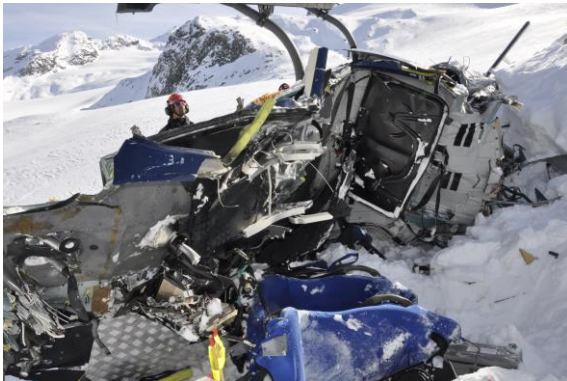
The cockpit was destroyed, as was the passenger cabin. The instrument panel was completely separated from the rest of the adjacent structures.

Photo 15: I-EDIC helicopter cabin.

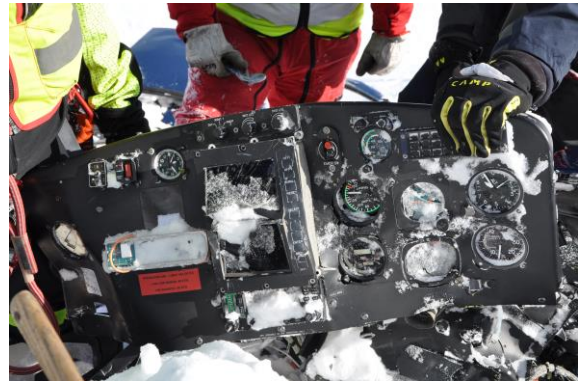
Photo 16: I-EDIC instrument panel.

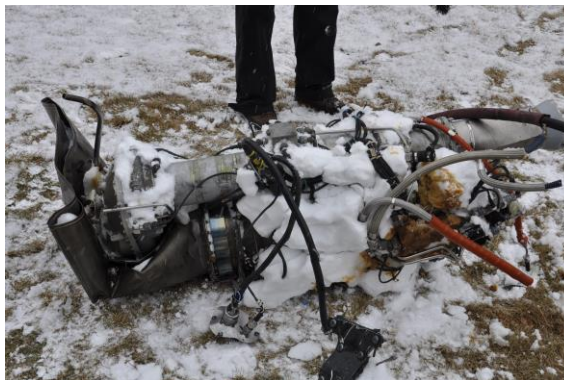
The turboshaft was found to be completely torn from its housing and with the drive shaft separated from the main transmission.

Photo 17: I-EDIC engine.

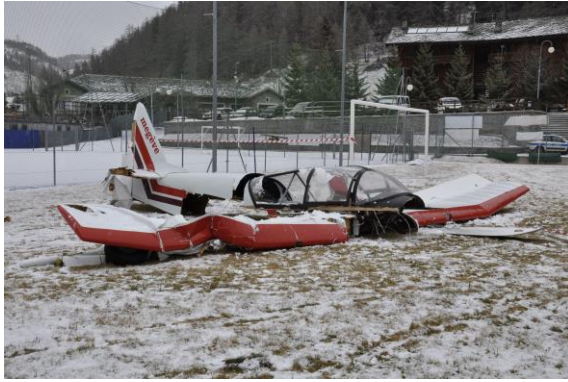
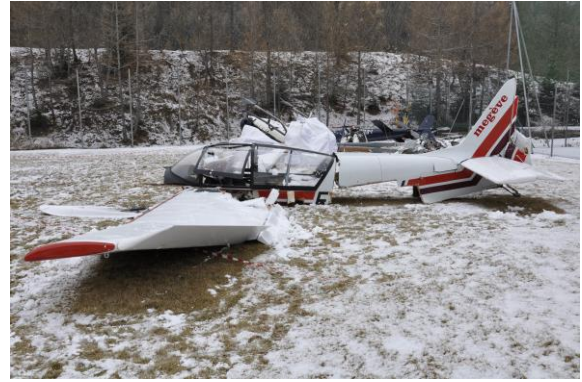
The fuselage was heavily damaged and the lower part was missing. The canopy, the rear seats, the engine compartment and the tail were also separated and found on the ground at some distance from each other.

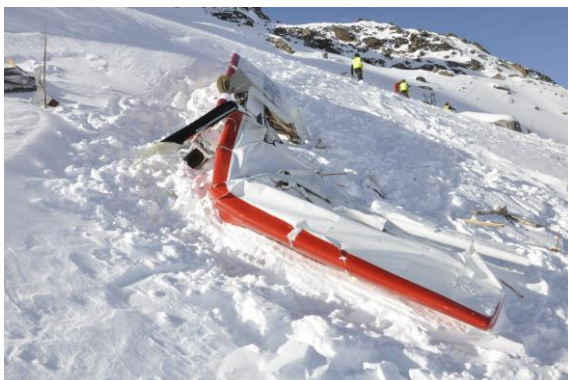
The wing was completely separated from the fuselage, with the right front seat still partially attached to the central structure, while the left seat was present close to it. The right wing had damages on its ventral part, damages not present on the left wing.

Photo 20: F-PMGV wing.

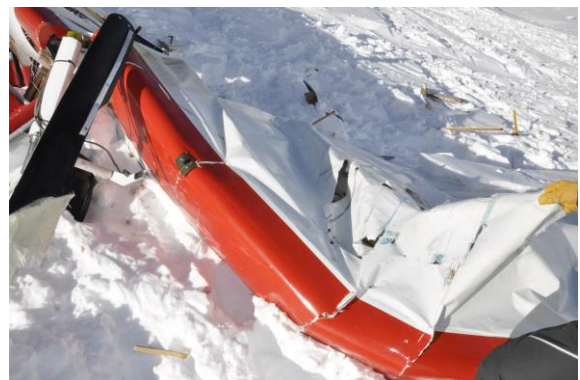
Photo 21: ventral side of the right wing, blu paint traces.

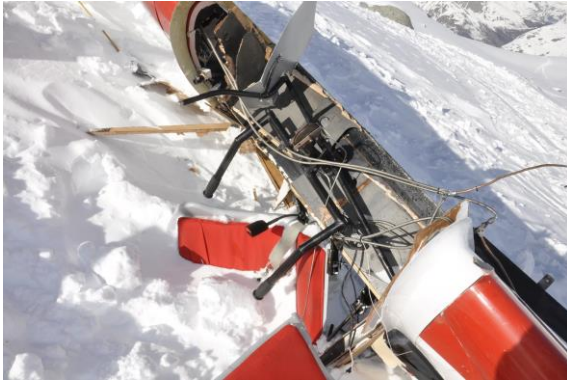
On the right wing, the position of the flap and aileron were not indicative, considering the high level of damage to the flight control rods, still partially attached to the wing inside together with the two front seats.

Photo 22: flight controls and pilots' seats.

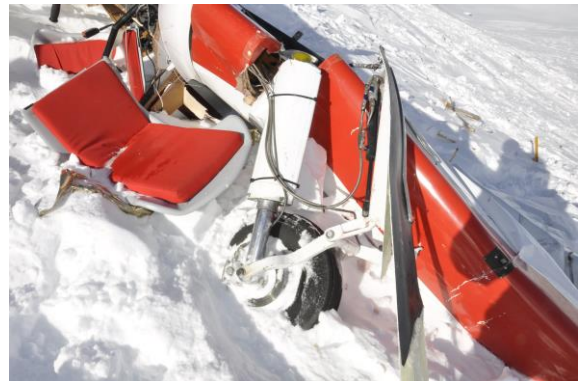
The right main landing gear was heavily damaged by impact with a metal objects, the ski attachment cables were cut and a large part of the ski was missing (Photo 25). The latter has been found at the lowest point respect to all the other parts scattered on the ground, having slipped on the snow for an estimated distance of some tens of meters (Photos 26 and 27).

Photo 25: right wing, landing gear and ski.

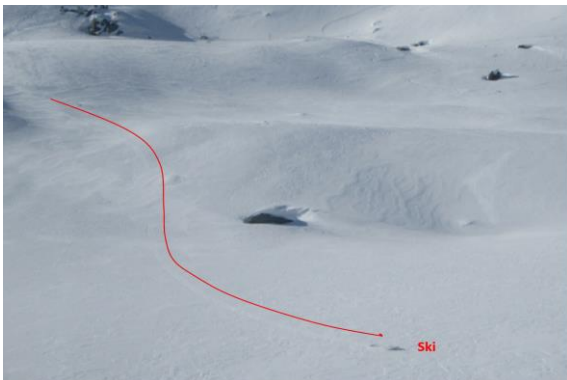
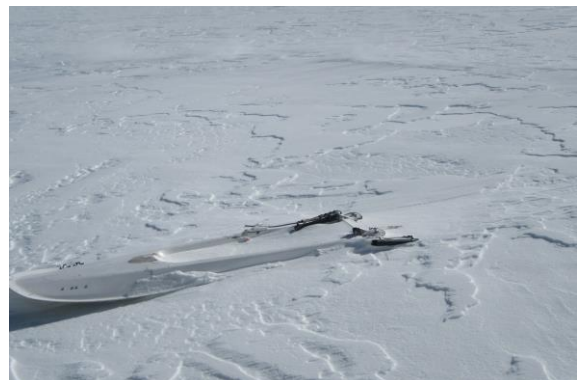
Photo 26: right wing landing gear ski,
slid down the valley

Photo 27: right wing landing gear ski

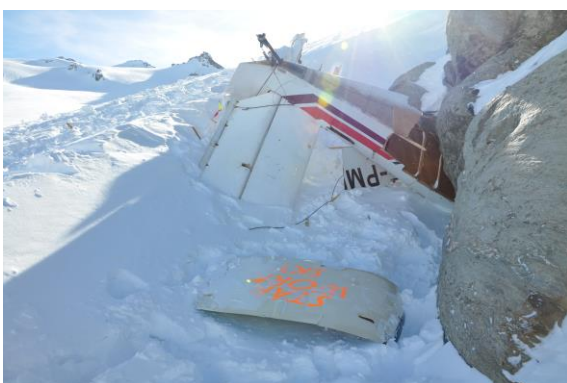
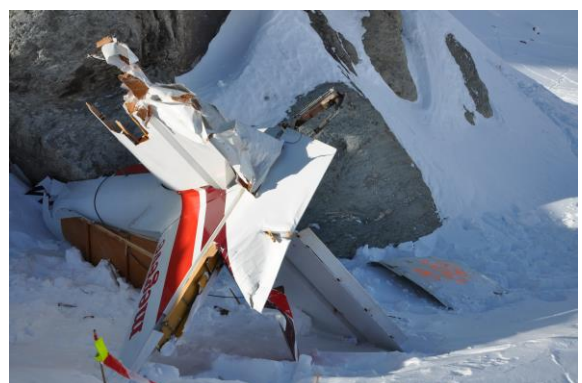
The tail and related moving surfaces were also found to be distant from the other parts of the airplane and heavily damaged.

Photo 32: F-PMGV tail cone and I-EDIC panel.

Photo 33: F-PMGV tail cone.

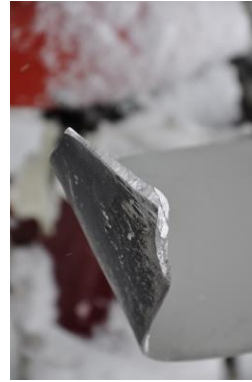
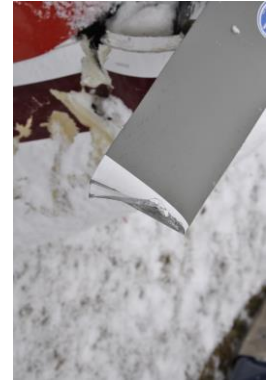
The engine was still connected to the engine mount and cowlings. The propeller blades shown clear damages at the tips due to multiple impacts against metal objects.

Foto 35: propeller blade tip.

Photo 36: propeller blade tip.

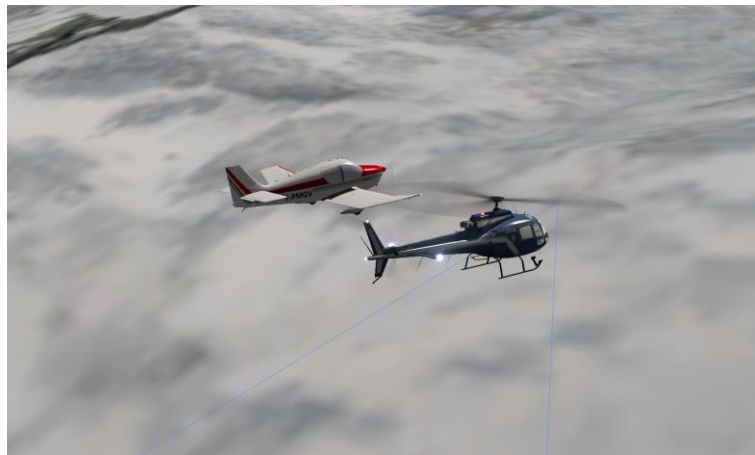
The initial impact was between the forward blade of the helicopter and the right main landing gear of the airplane, followed by subsequent impacts of the blades against the lower side of the aircraft fuselage and the ventral part of the right wing.

Figure 7: reconstruction of the impact between I-EDIC and F-PMGV (ANSV animation; the silhouette of a similar aircraft has been used to simulate F-PMGV).

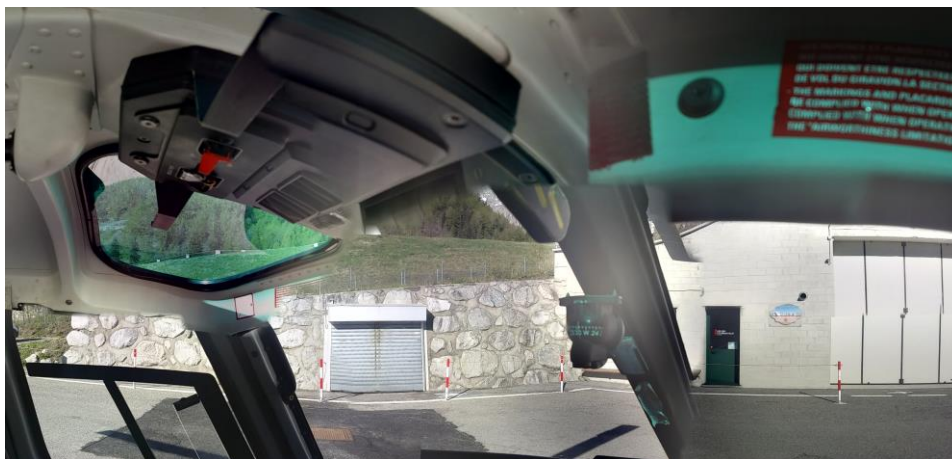
- He was seated in the right front seat (the captain's seat), thus opposite the side from which F-PMGV was arriving.
- He was tall (about 1,90 m), thus further limiting the visibility in the upper left sector of the helicopter, which is already very limited (see the following picture that shows the visibility available to a pilot of that height in that sector).

Photo 40: AS350 B3, visibility upper left side from the captain's seat.
