Rapport final no. 2148

concernant les risques encourus par les services de sauvetage et d'enquête avec les systèmes de sauvetage par parachute balistique (*Ballistic Parachute Systems – BPS*) dont certains avions sont équipés.

Thermal behavior of BRS 440 and BRS 601 rockets

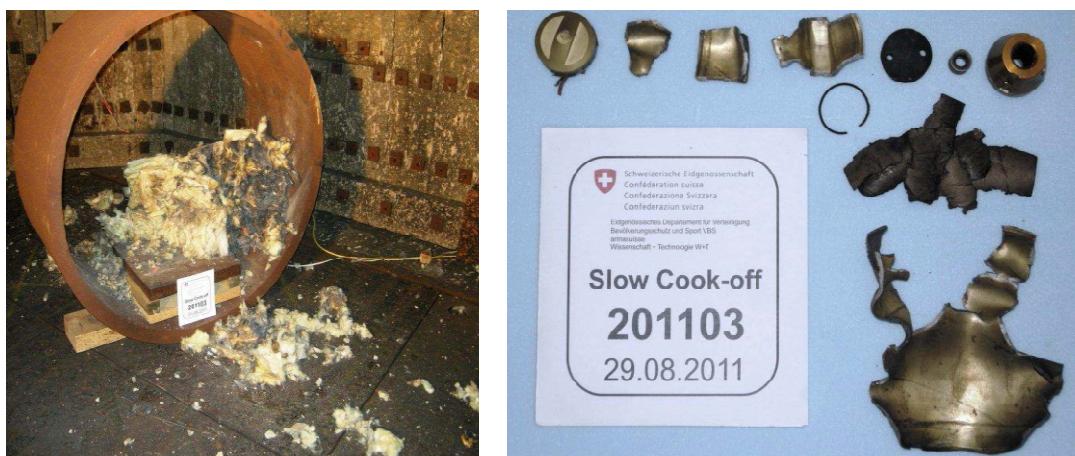
Cette réaction s'est manifestée par une explosion durant laquelle le boîtier en aluminium de la fusée a volé en éclat.

Illustration 12: Résultats des tests et fragments

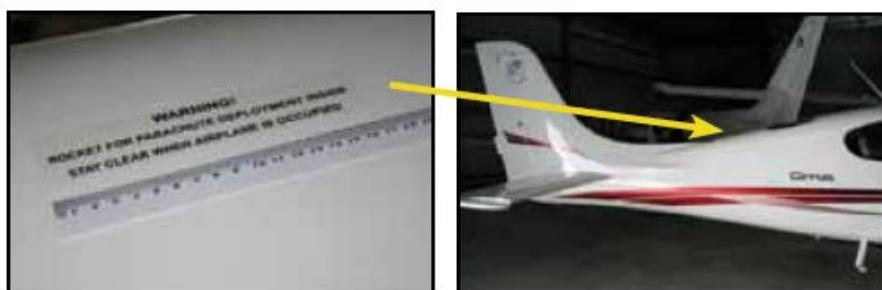
Cirrus aircraft warning decal

Actuellement ces avions sont pourvus de petites étiquettes autocollantes de 40 mm de côté. Ces étiquettes avertissent des dangers du BPS et donnent comme directive aux secouristes d'appeler un numéro de téléphone aux Etats Unis avant de commencer le sauvetage.

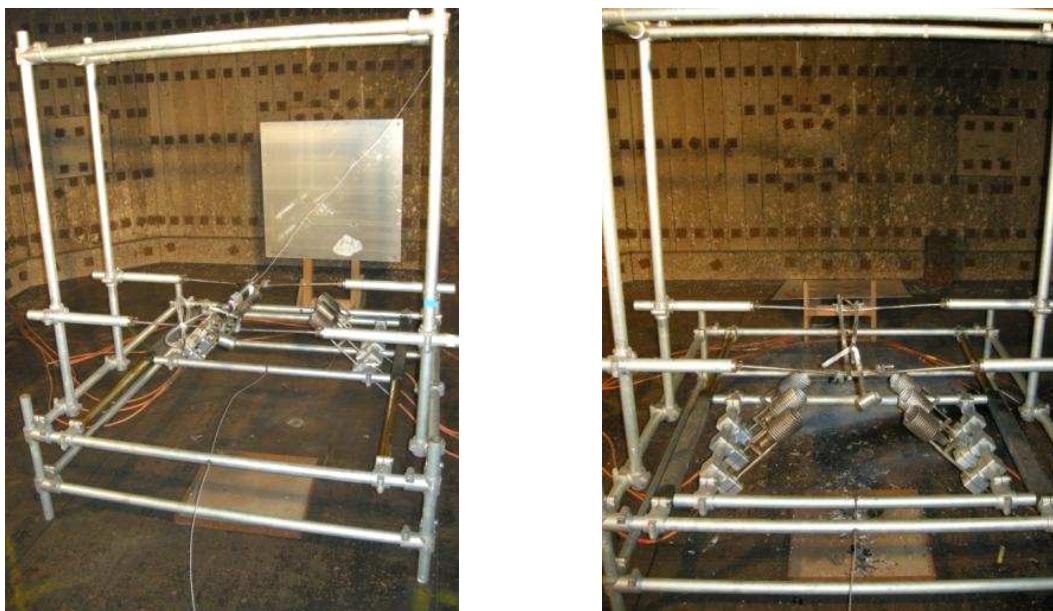
Test Nr. / Rocket	Mean Temp. [°C]	Time to Reaction [s]	Type of Reaction ¹	Remarks
V01/ BRS 440 Nr. 2	1045	145	Type V-IV Fast burning towards deflagration	End cap was axially ejected out of the rocket casing with high velocity. The main part of HTPB cylinder of the rocket motor did not react. Both percussion cups of the Igniter did not react.
V03/ BRS 440 Nr. 3	1085	129	Type V-IV Fast burning towards deflagration	The end cap was axially ejected out of the rocket casing with high velocity. One wire cut and the second wire almost cut. No unreacted rocket motor parts left. Igniter including primary booster remained unreacted.
V02/ BRS 601 Nr. 1	1050	43	Type V-IV Fast burning towards deflagration	The rocket was axially ejected apart from the fixation and penetrated the 2 mm thick aluminum witness plate (see Fig. 7). The outer casing of the rocket was ejected to the opposite witness plate which resulted in a crack into the plate. All parts of the rocket motor and igniter did react.

Fig. 4: FCO test V01 of BRS 440; before (left) and after the test (right).

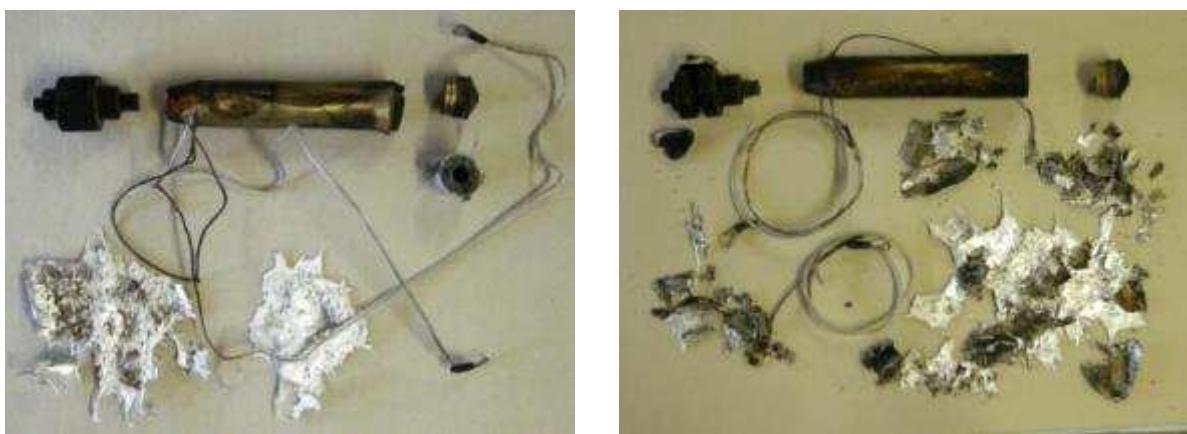
Fig. 6: FCO results for the BRS 440 respectively for test V01 (left) and test V03 (right).

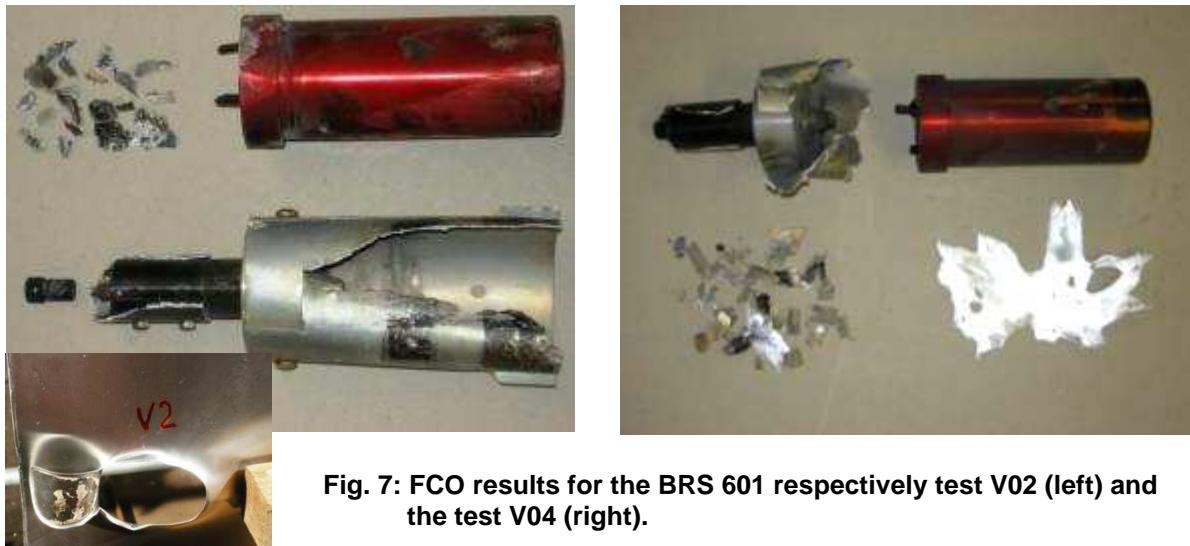
V04/ BRS 601 Nr. 2	1065	69	Type V-IV Fast burning towards deflagration	The rocket remained onto the support but shifted the whole test equipment about 1.5 m in the direction of the base of the rocket. All parts of the rocket motor and igniter did react.

Fig. 7: FCO results for the BRS 601 respectively test V02 (left) and the test V04 (right).

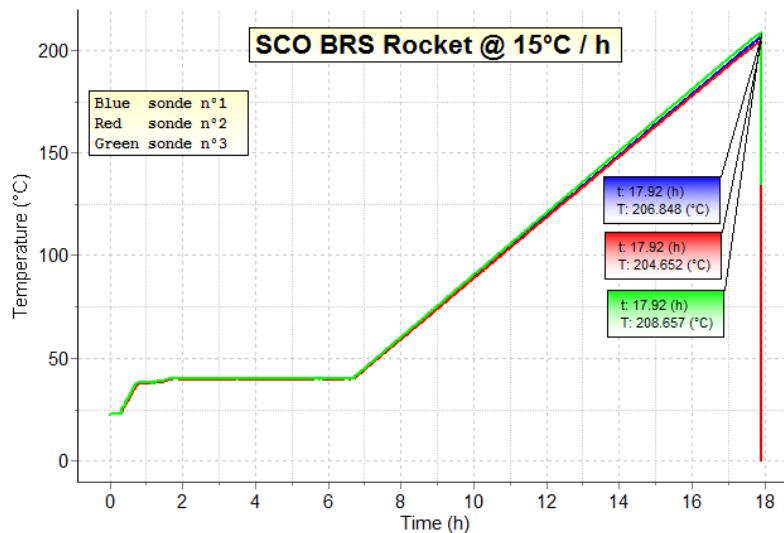
Fig. 9: SCO heating curves for the BRS 440 rocket at 15°C per hour.

The violent reaction corresponds to a type IV – III started after 18 hours at a temperature of around 207°C. The differences in temperature between the three probes originate most probably by the geometry of the rocket and the heating system which is not fully symmetrically.

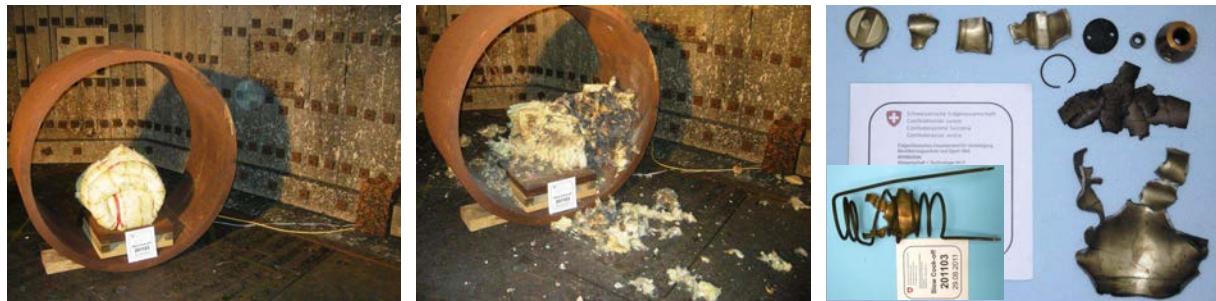
Fig. 10: SCO of the BRS 440 rocket; respectively before and after test and the fragments.

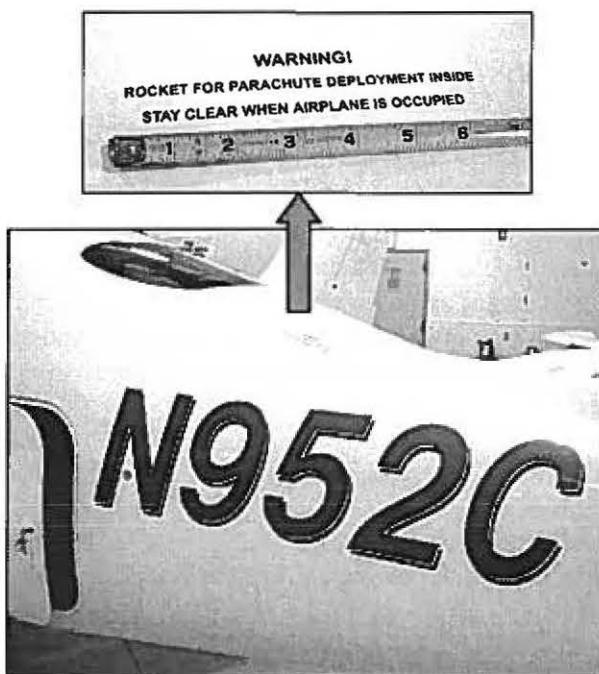
Figure 1. CAPS warning label for Cirrus SR20 and SR22 airplanes
