Aviation Investigation Final Report

Location:	Oberlin, Kansas	Accident Number:	CEN23LA344
Date & Time:	July 20, 2023, 12:36 Local	Registration:	N36900
Aircraft:	Beech A36	Aircraft Damage:	Substantial
Defining Event:	Fuel starvation	Injuries:	1 Minor, 1 None
Flight Conducted Under:	Part 91: General aviation - Personal

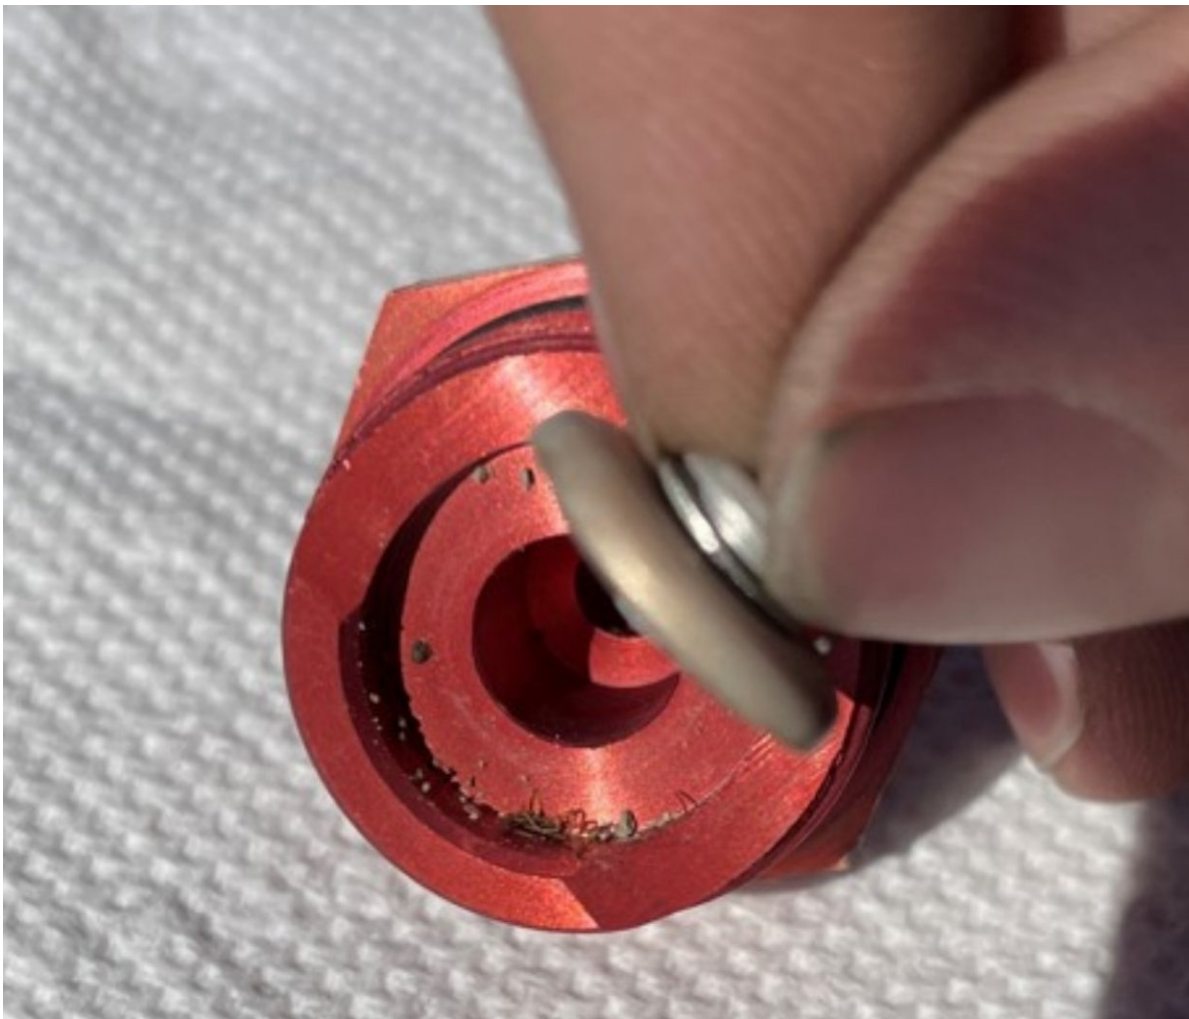
Figure 1: Left tank fuel vent check valve.

Examination of the fuel system revealed that the fuel venting system on the left-wing fuel tank was obstructed by what appeared to be insect debris. No other anomalies were noted during the examination of the airframe and engine that would have precluded normal operations.

The circumstances of the power loss are consistent with an interruption of fuel flow from the left fuel tank due to inadequate venting of the fuel tank.

The blockage of the left fuel tank vent, which resulted in a total loss of engine power due to fuel starvation. Contributing to the accident of the pilot's failure to use his checklist to address the loss of engine power.

The National Transportation Safety Board performed a postaccident examination of the airframe and engine. The examination revealed an obstruction in the left tank fuel vent. The one-way check valve in the fuel vent was observed stuck in the closed position, not allowing air through. When the fuel vent line was pressure tested the obstruction became dislodged. Further examination of the check valve revealed debris inside consistent with insect debris (Figure 1). No other mechanical anomalies were noted during the examination that would have precluded normal operation.
