FINAL REPORT

ACCIDENT

**AS350 B3 reg. marks I-EDIC and Jodel D.140E reg. marks F-PMGV,
at Rutor glacier, La Thuile (AO),
January 25th 2019**

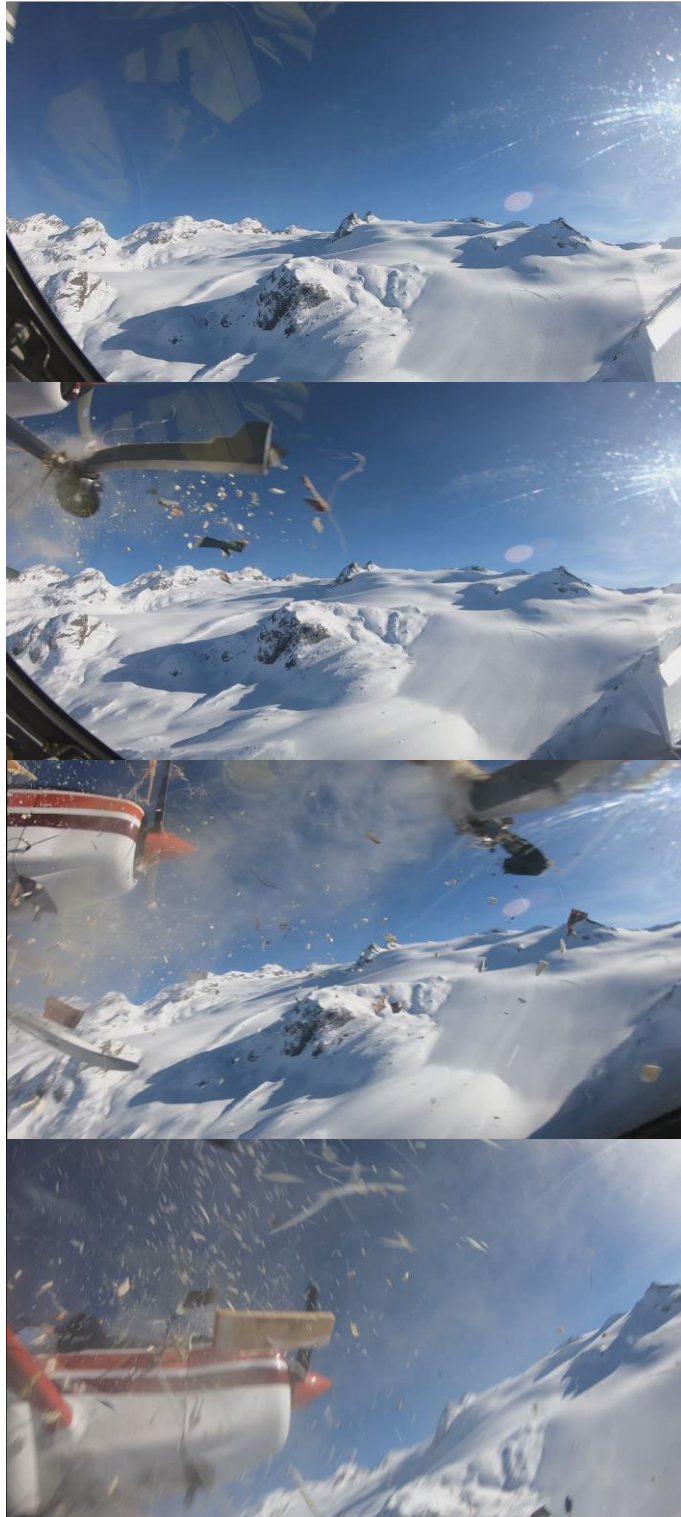
Photo 5: frames of the impact with F-PMGV, taken from the mountain guide camera.

The moment of impact is instead extracted from the footage retrieved from the camera installed on the helmet of the mountain guide, who is in a more favorable position to document the first impact with F-PMGV.

To be noted that from the lateral windows of the front left seat, the airplane becomes visible only at the time of impact.

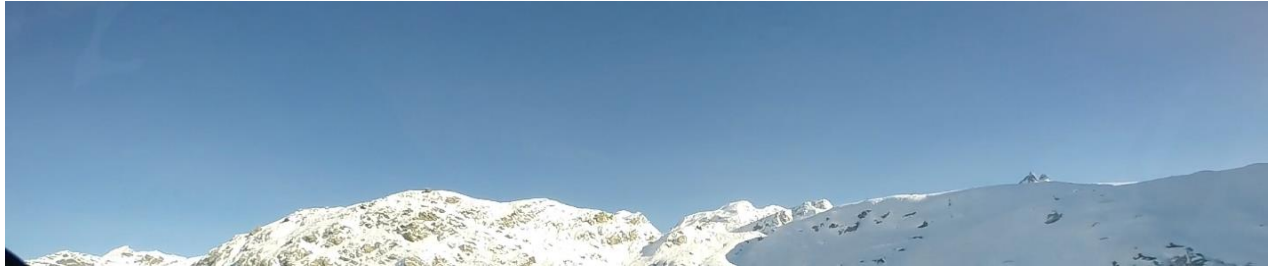
Photo 6: Sky visible to the east, about 50 seconds before the collision.

Throughout the entire duration of the film, in the in the visible portion of the sky framed by the camera, there are no indications of other aircraft present in the area.

In particular, 50 and 40 seconds before the impact, the east and south sectors of the surrounding sky, respectively, are framed by the camera, without the presence of any aircraft in the visible portion of the sky.

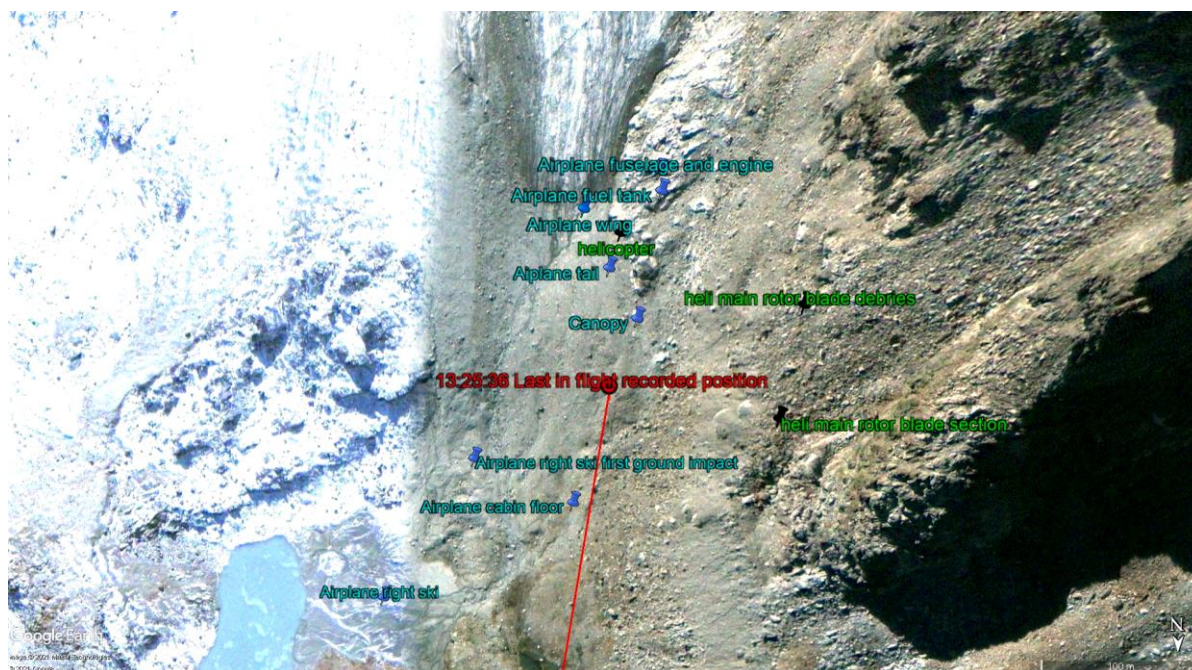
Figure 6: Wreckage distribution (on Google Earth Pro).

From the following image, it is possible to verify that the skid of the aeroplane (its point of initial impact on the ground (it then slides towards the valley, see photo n. 26 and 27) and the blade section of the helicopter rotor, are the most significant and closest parts to the last point recorded by the in-flight tracking system of the helicopter.

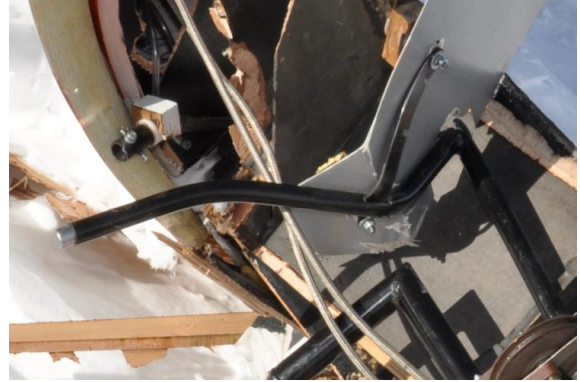
Photo 23: flight controls.

As for the flaps, on the left wing the surface was free to rotate and there were deformations and partial breakage of the flaps control linkage (base of the control lever shaft, photo 22 and flap control lever shaft, photo 23).

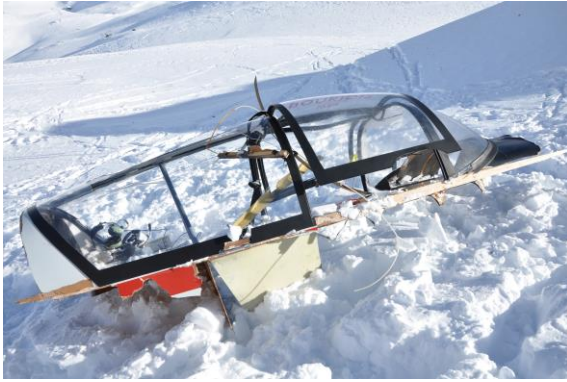
Photo 28: F-PMGV canopy.

The upper part of the cockpit, essentially the canopy, and the rear seat cushion, were found distant from the rest of the fuselage components.

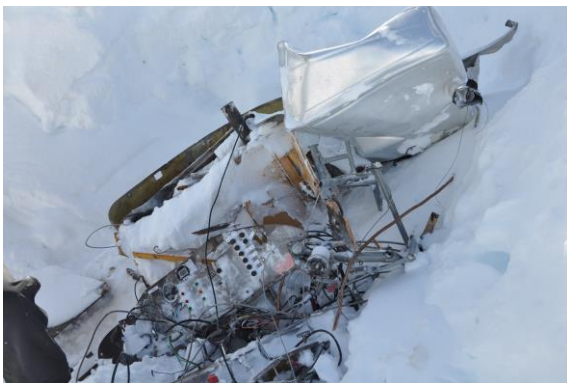
Photo 30: F-PMGV instrument panel.

The instrument panel and engine controls were found separated from the rest of the fuselage, together with the fuel tank and near the engine mount.

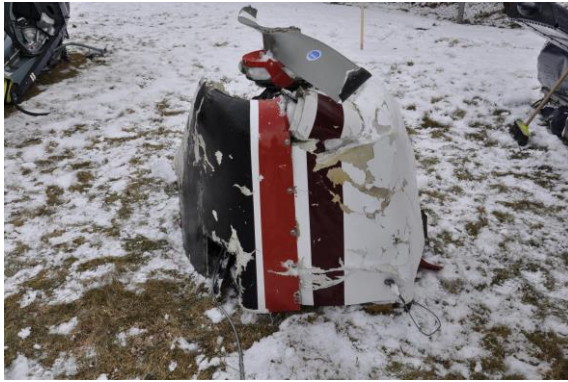
Photo34: F-PMGV engine cowlings.

The engine was still connected to the engine mount and cowlings. The propeller blades shown clear damages at the tips due to multiple impacts against metal objects.

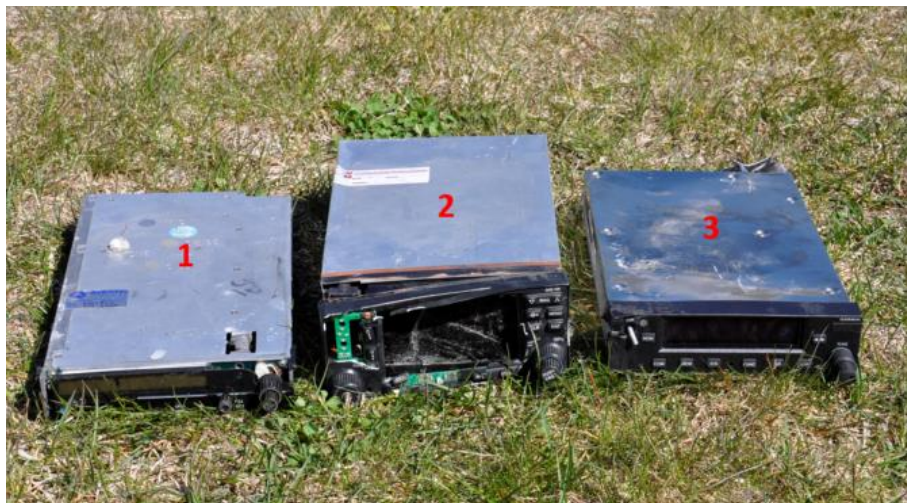
Photo 37: radios from the two aircraft: n. 1 from F-PMGV; n. 2 and n. 3 from I-EDIC.

In a subsequent wreckage survey, carried out on May 14th, 2019, in coordination with the judicial authority that had placed both wreckages under seizure (located at the sport field of the municipality of La Thuile), the ANSV removed a Honeywell K97A radio (Photo 37, part. 1) from F-PMGV and two radios from I-EDIC (Garmin GNS 430 and Garmin GTR 225A, respectively part. 2 and part. 3 of Photo 37) from their respective instrument panels, for their subsequent transfer to the laboratories of the same ANSV.

The GMA340 radio control panel was not found among the wreckage parts moved to the sport field.

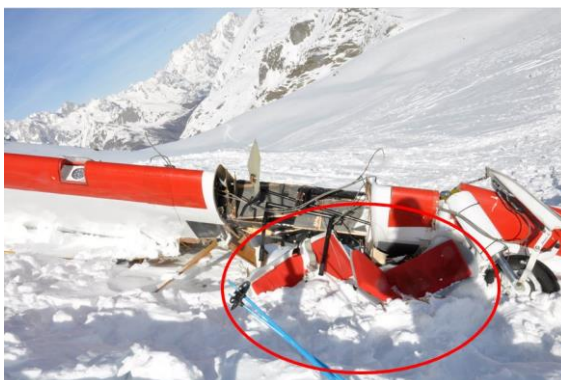
Photo 38: survivor position on F-PMGV.

In particular, the pilot instructor on board of the F-PMGV was found still belted to the right front seat, which was partially restrained to the wing structure; he was released from the belt thanks to the intervention of the rescuers on the scene.

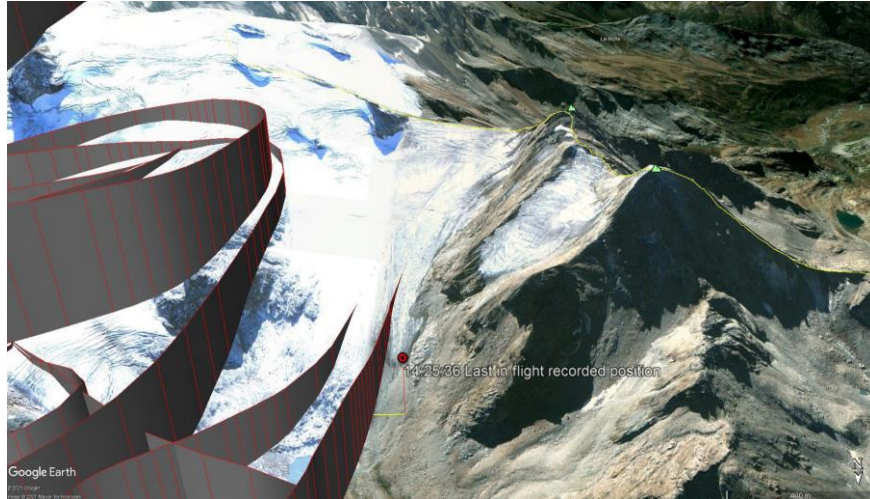
Figure 16: flight trajectories for landing to and take-off from Col Loydon with respect to the last I-EDIC recorded position in flight.

In support of the hypothesis that the F-PMGV was landing is the fact that the position of the last recorded point of the helicopter was close (about 50/60 m) to the flight path of another aircraft, which had also landed on Col Loydon and whose flight path could be acquired (see figure 16).

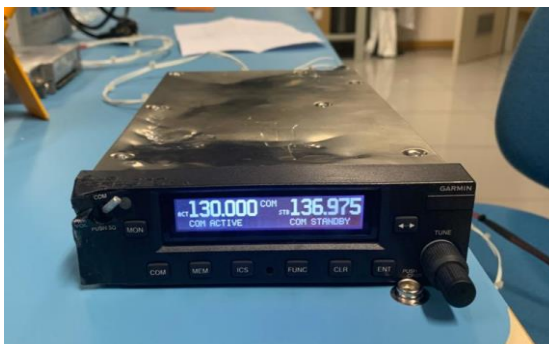
Photo 39: Garmin GTR 225A radio, recovered from the I-EDIC wreckage, powered in the ANSV laboratories.

It was possible to proceed, after technical checks, to provide electric power to the radio and obtain the following presentation on the display: on the left side, as "COM ACTIVE", the

frequency of 130.000 MHz, while on the right side, as "COM STANDBY", the frequency of 136.975 MHz. No changes have been made to the control position and settings already present on the front panel.

The latter frequency is the upper limit of the aeronautical VHF band and therefore the maximum frequency that can be selected by the radio; this frequency does not coincide with any of the frequencies in use among the various operators involved in the accident or local operators, nor with the AFIU of Aosta airport or other operators operating in the district of Valgrisenche, Arvier and La Thuile.

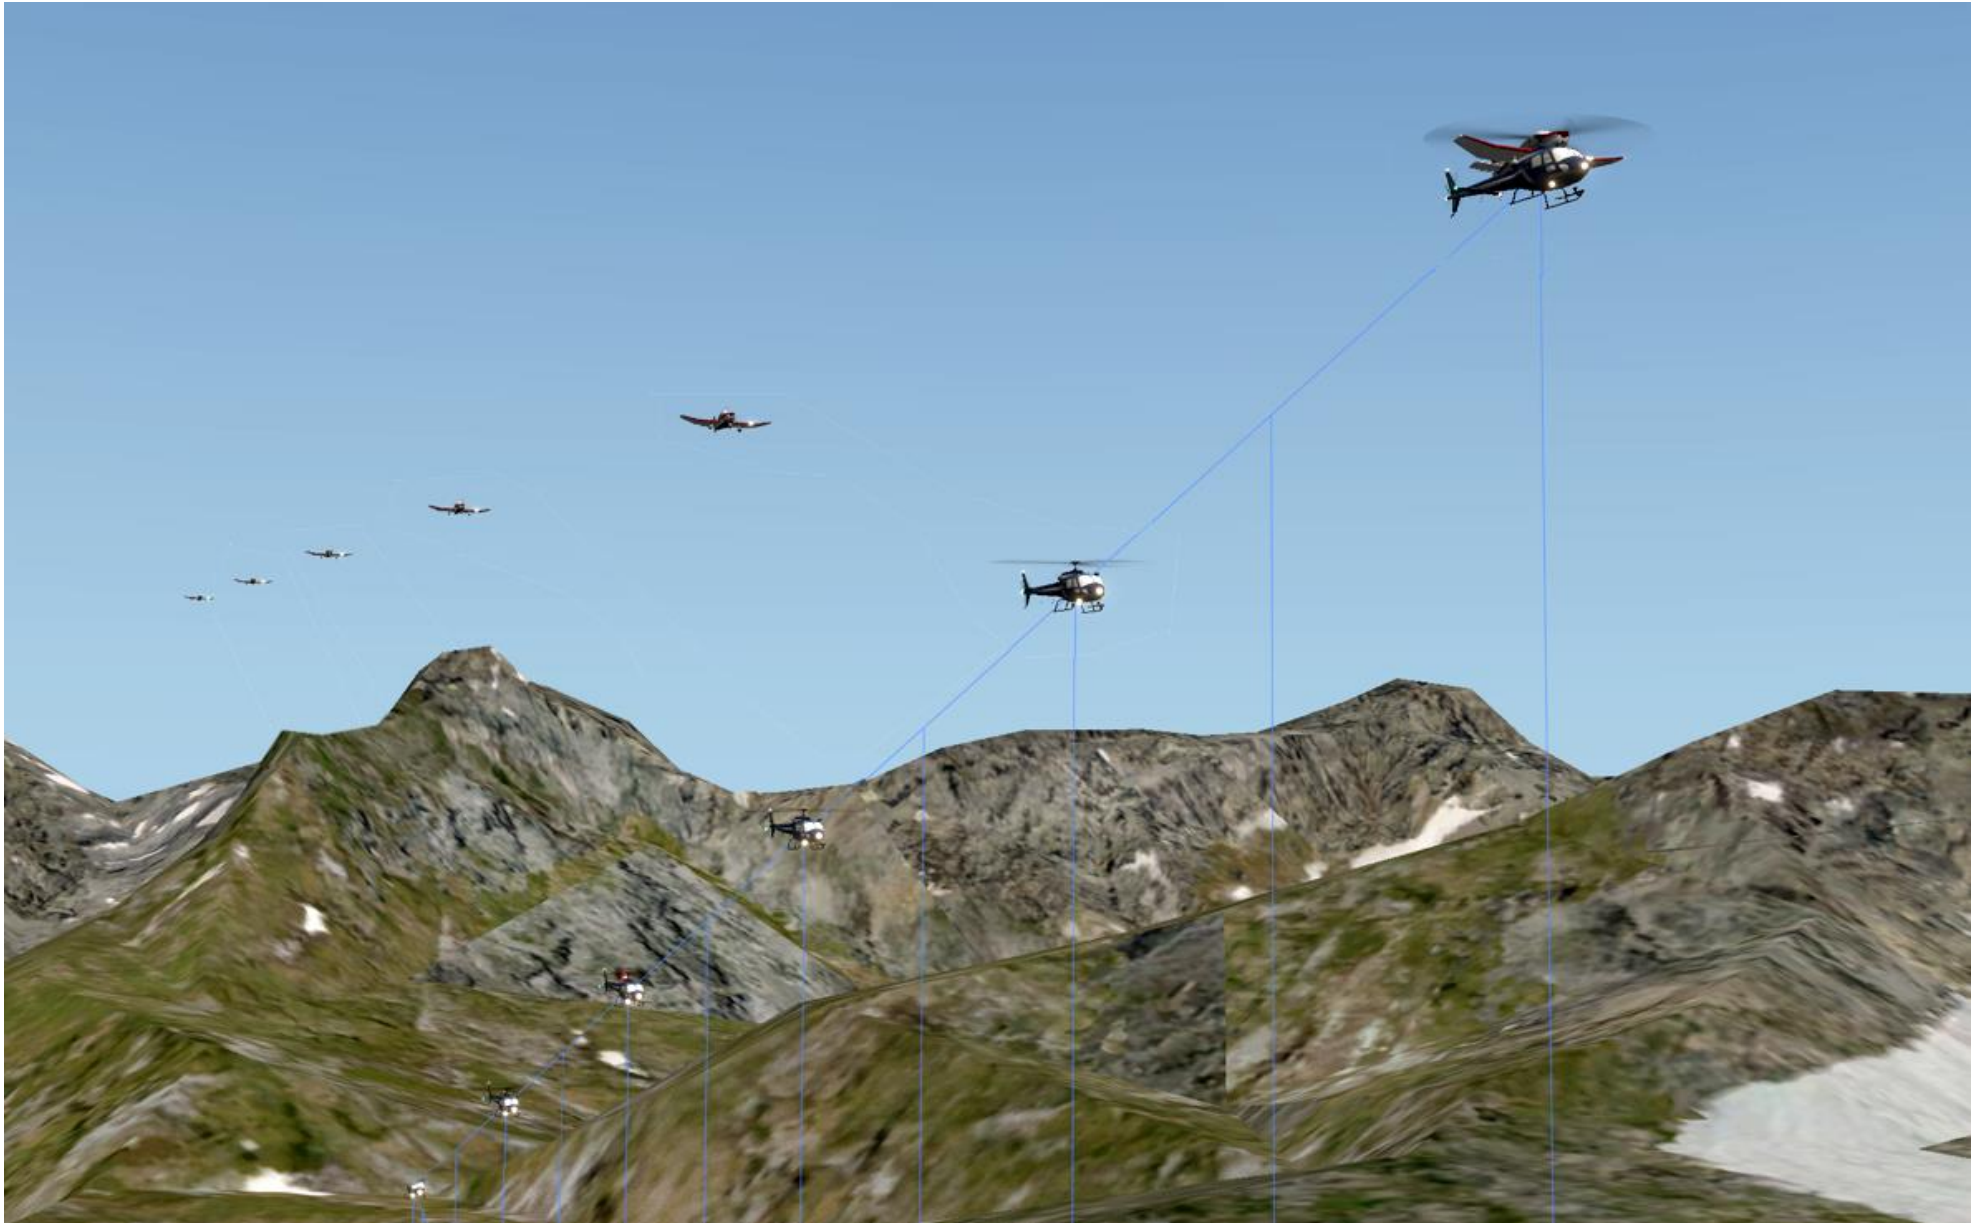
The following figure the flight paths of the two aircraft are shown, whose relative positions are reported every two seconds, starting from ten seconds before collision. While for the I-EDIC the flight path is the one indicated by the data provided by the “Bolero” system, for the F-PMGV an IAS of 120 km/h (equivalent to a GS of about 141 km/h, considering the altitude of about 9100 feet) and a flight direction of about 190° have been assumed, i.e. the one approximately required to land on Col Loydon.

Figure 19: ANSV reconstruction of the trajectories of the two aircraft from ten seconds before the collision (from ANSV animation; the silhouette of a similar aircraft has been used to simulate the F-PMGV).
