Rapport final no. 2148

concernant les risques encourus par les services de sauvetage et d'enquête avec les systèmes de sauvetage par parachute balistique (*Ballistic Parachute Systems – BPS*) dont certains avions sont équipés.

Thermal behavior of BRS 440 and BRS 601 rockets

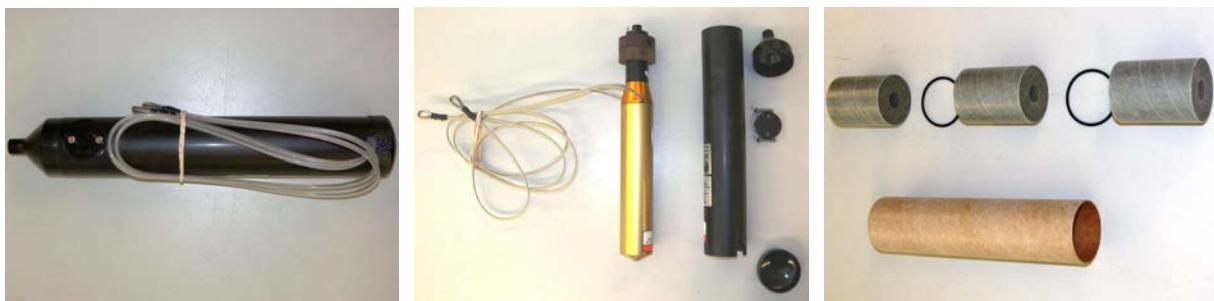
- rocket motor (HTPB/AP/Mg) three cylinders, 71.3 g each
- primary booster (BP/Mg) 160mg
- primer mixture (composition unknown) 300mg

Fig. 1: Main components of the BRS 440 rocket; the 3 gray cylinders at the top of the rightmost picture compose the rocket motor.

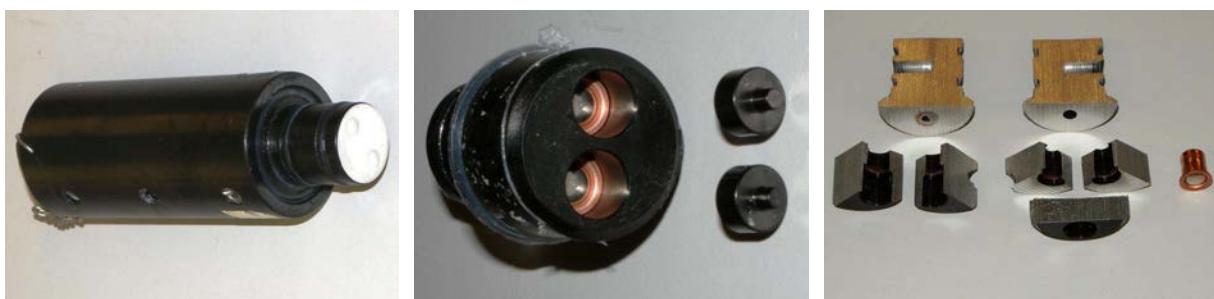
Fig. 2: Detail of the igniter of the BRS 440 rocket. The primary booster charge is contained in two firing channels under an aluminum foil (glued to the base of the igniter; left picture). The picture in the middle shows the two percussion cups in the igniter housing and the two firing pins beside. The rightmost picture shows one of the two percussion cups and the housing cut by a diamond wire saw.

The active parts in the BRS are mechanically well protected and sealed properly. This is of great importance as Magnesium (Mg) reacts with humidity by the time under production of hazardous hydrogen gas.

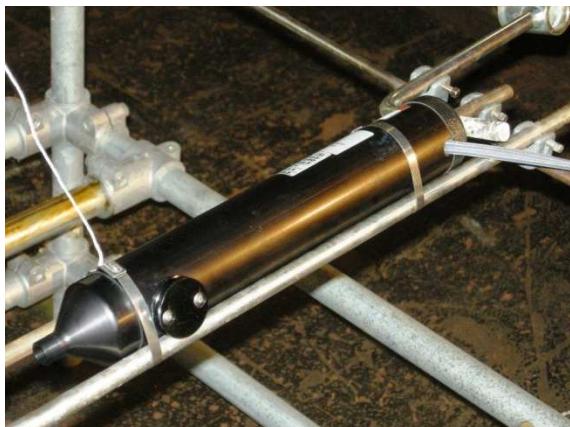
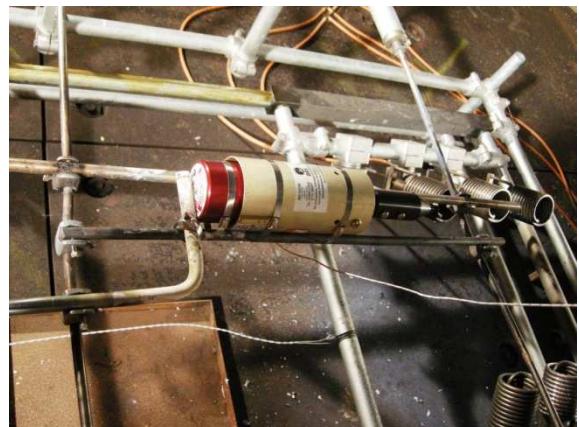
Test Nr. / Rocket	Mean Temp. [°C]	Time to Reaction [s]	Type of Reaction ¹	Remarks
V01/ BRS 440 Nr. 2	1045	145	Type V-IV Fast burning towards deflagration	End cap was axially ejected out of the rocket casing with high velocity. The main part of HTPB cylinder of the rocket motor did not react. Both percussion cups of the Igniter did not react.
V03/ BRS 440 Nr. 3	1085	129	Type V-IV Fast burning towards deflagration	The end cap was axially ejected out of the rocket casing with high velocity. One wire cut and the second wire almost cut. No unreacted rocket motor parts left. Igniter including primary booster remained unreacted.
V02/ BRS 601 Nr. 1	1050	43	Type V-IV Fast burning towards deflagration	The rocket was axially ejected apart from the fixation and penetrated the 2 mm thick aluminum witness plate (see Fig. 7). The outer casing of the rocket was ejected to the opposite witness plate which resulted in a crack into the plate. All parts of the rocket motor and igniter did react.

V04/ BRS 601 Nr. 2	1065	69	Type V-IV Fast burning towards deflagration	The rocket remained onto the support but shifted the whole test equipment about 1.5 m in the direction of the base of the rocket. All parts of the rocket motor and igniter did react.

Fig. 3: FCO set-up; respectively for the BRS 440 (left) and the BRS 601 (right).

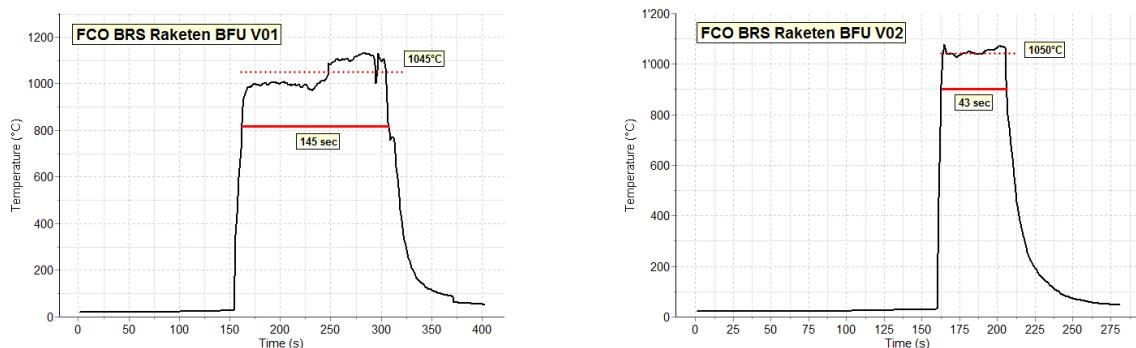
Fig. 5: FCO curves respectively for the BRS 440 (left) and the BRS 601 (right).

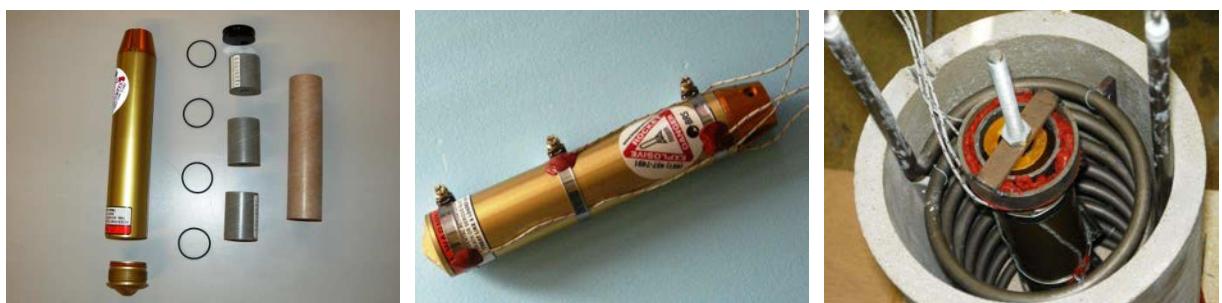
Only one type of BRS rocket was left to perform an indicative SCO experiment; BRS 440 Nr. 1 which was used for dismantling. The test was performed without Igniter (used for analytical tests) and with an aluminum disc of 1 cm thickness for confinement towards the rocket nozzle. The first HTPB cylinder of the rocket motor weighted 57.3 g instead of 71.3 g. We have chosen a heating rate of 15°C/h for this experiment which corresponds to a realistic heating rate for the thermal radiation of a fire in the vicinity.

Fig. 8: Arrangement of the BRS 440 rocket for the SCO test; respectively rocket with probes and in position in the brick cylinder.

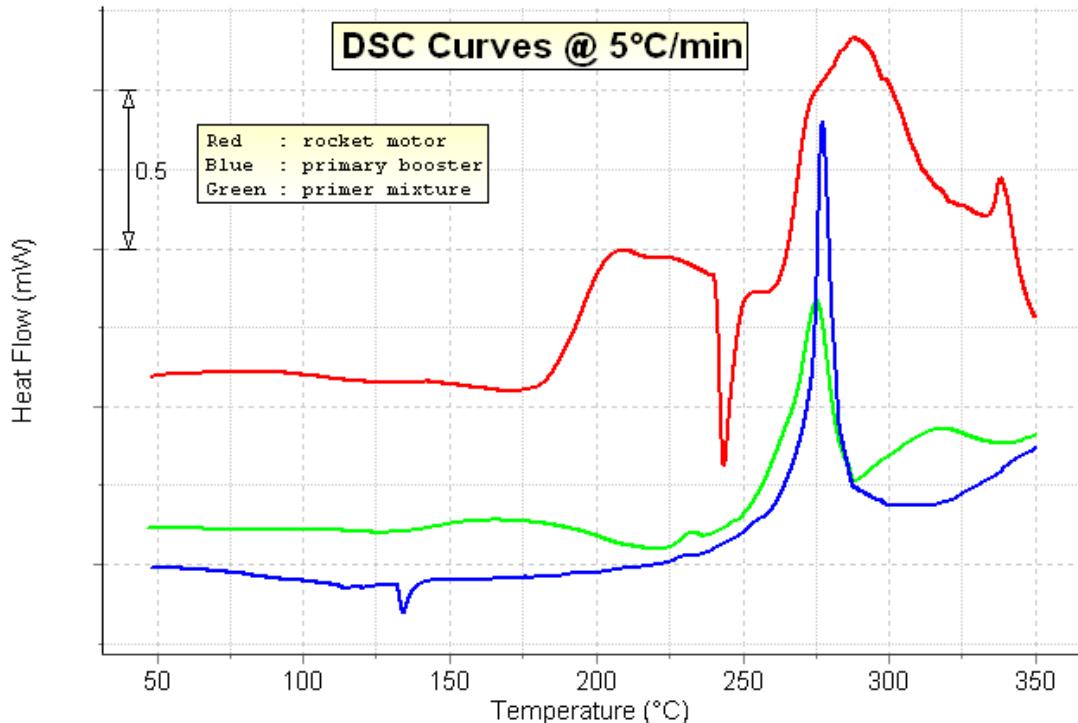
**Fig. 11: DSC curves of the rocket motor, the primary booster and the primer mixture with a heating rate of 5°C per minute.**

The DSC experiments have shown that for a heating rate of 5°C per minute, the rocket motor is the sample which shows first an exothermic reaction at 180°C (cf. fig. 11). In comparison the primary booster and the primer mixture seem to be thermodynamically more stable.

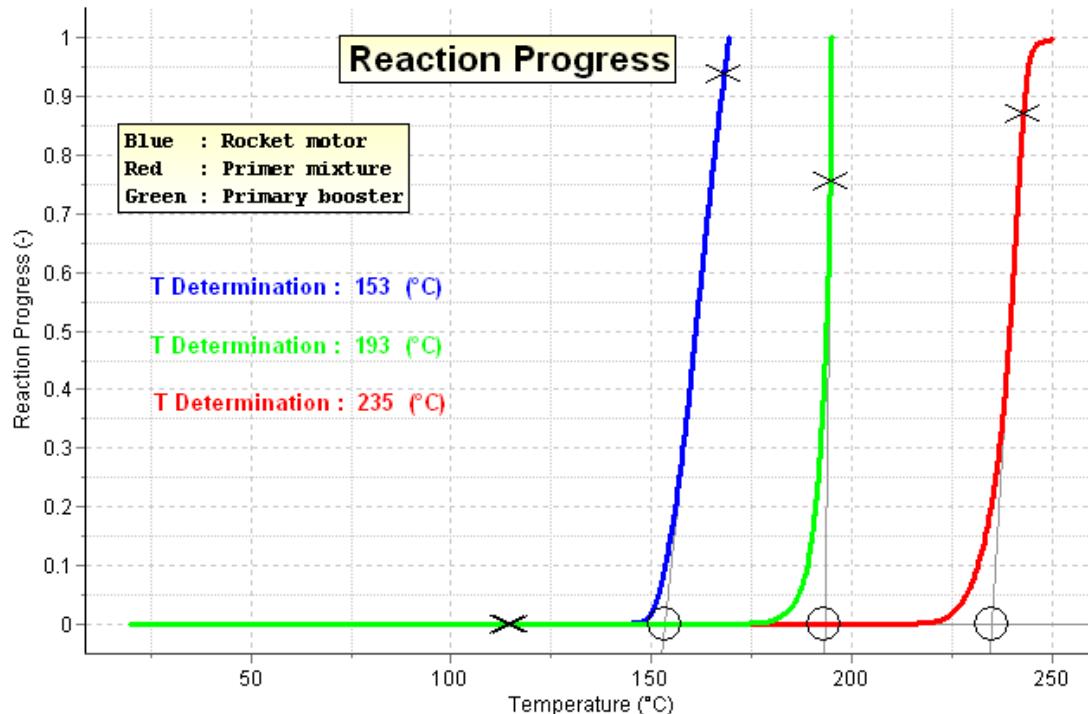
Fig. 15: Prediction of the reaction progress under adiabatical condition for a heating rate of 15°C per hour; the blue curve represents the rocket motor, the green curve the primary booster and the red curve the primer mixture.

For the thermodynamical simulations we had to make a compromise due to the high inhomogeneity of the sample in the milligram domain. This was especially the case for the HTPB rocket motor. For the simulation we could use only the first exothermic peak (up to 220°C) instead of the full spectrum as for the other two substances. Figure 15 shows the reaction progress of the three samples in an adiabatically configuration. Although that this condition does not totally fulfill to the SCO test set-up, it is reasonable to assume that with a heating rate of 15°C per hour, the rocket motor will probably react first.

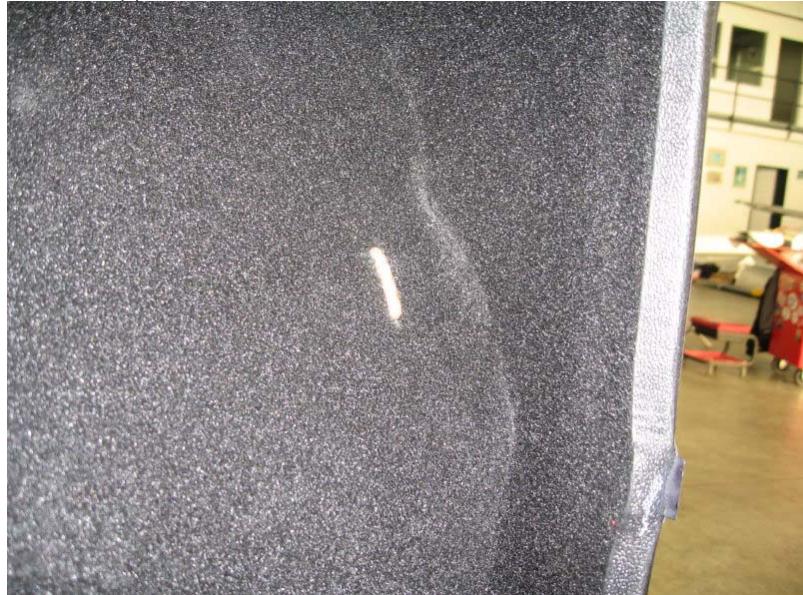
Beule in Gepäckraum,
Abdeckung entfernen

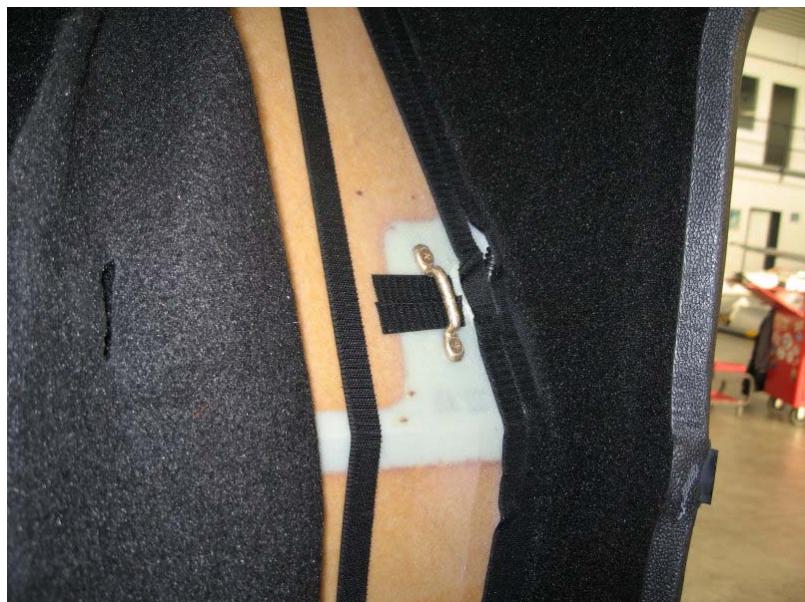
Kabelzug sichtbar

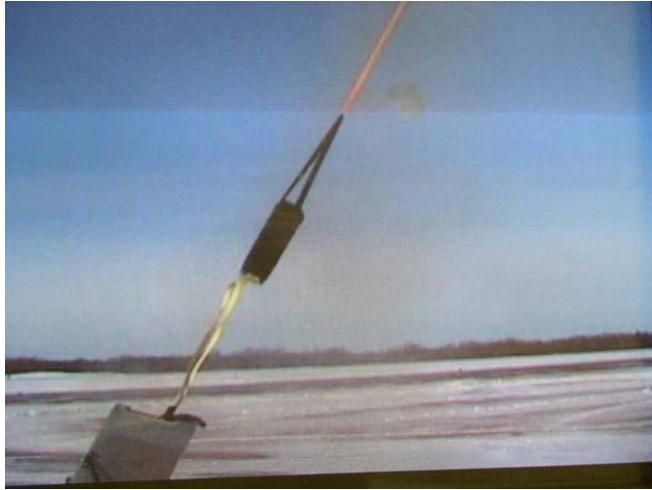
The rocket motors are ignited by pulling an activation handle in the cockpit. They then accelerate to over 100 mph in the first tenth of a second after ignition. While the total firing period is only one second, someone in the path of an escaping rocket could be seriously injured or killed. These are powerful rockets (about 1½-2 inches diameter and 8-10 inches long) that work very efficiently. At left is a test of a Cirrus system showing the 55 pound parachute pack being pulled by the rocket motor. This is a fraction of a second after ignition.

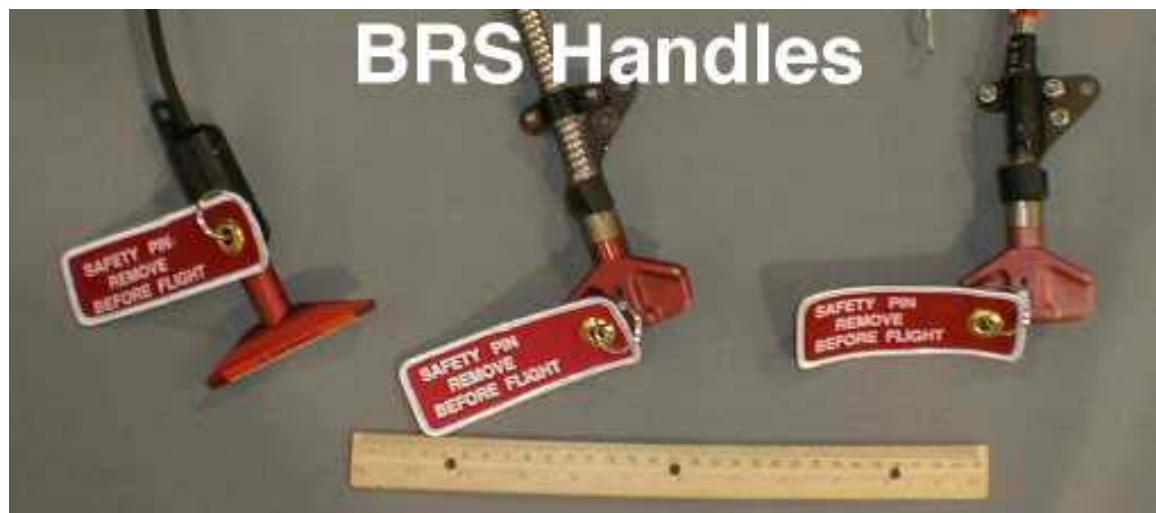
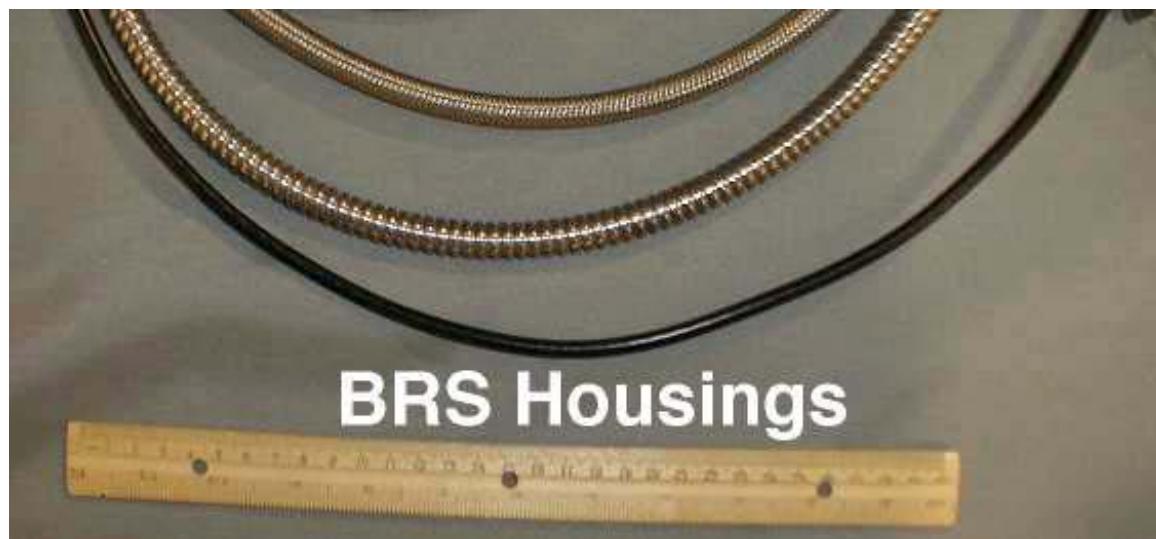
In the picture below, see that each handle is secured with a safety pin. This is to remain with the handle until the aircraft departs for flight, at which time the pilot should then remove the pin. **A first step for emergency personnel is to place some type of 3/16 inch pin or rod into the handle holder.** This provides some measure of security as you proceed to further disarm the system.

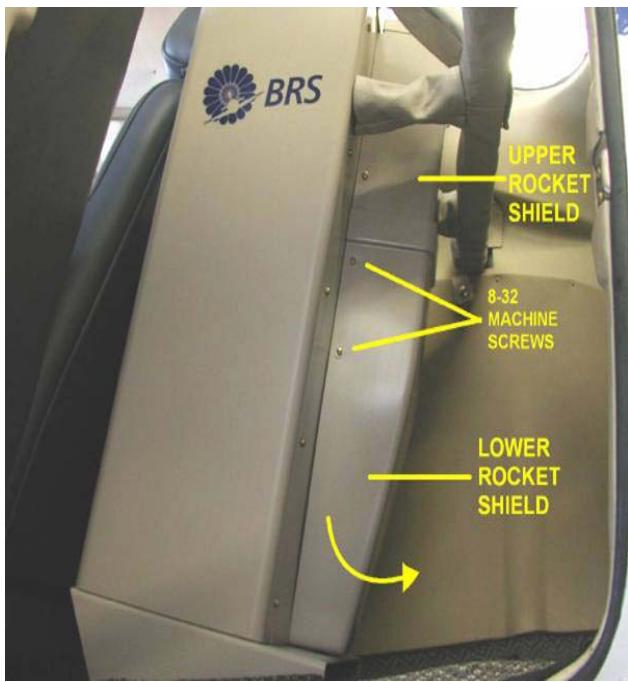
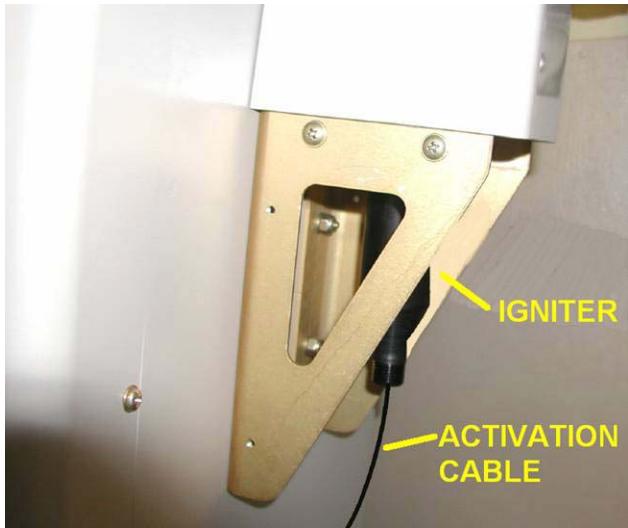
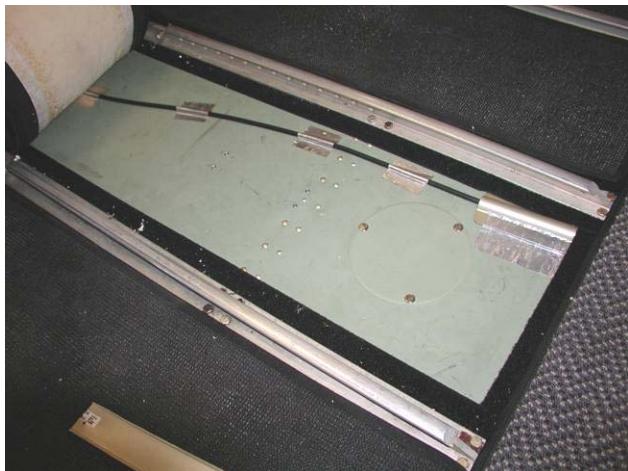
Many of the design elements of the newer, C182 ballistic parachute system are similar to its predecessor, the C172. The canister is rotated 90 degrees and the rocket is located *aft* of the canister, however, the activation cable is still relatively accessible prior to being covered on the floorboard. The best way to reach the cable would be through the left side baggage door, if possible. As shown here, the rocket motor and igniter are covered by the upper and lower rocket shields, which are intended to protect the components from bumping. To gain access to the cable, perform the following steps:

1. Using a Phillips screwdriver, remove the two 8-32 screws securing the left side of the lower rocket shield
2. Place force on the shield in an effort to move it *away* from the parachute canister. Even though there are two more screws on the right side, it should fracture and may then be pushed out of the way.
3. You will then see the igniter and the activation cable, as at left.
4. Using the Felco cutter, or equivalent, proceed to cut the cable 1" – 2" from the end.
5. The rocket has now been rendered safe, and it may be removed for disposal or safe storage.

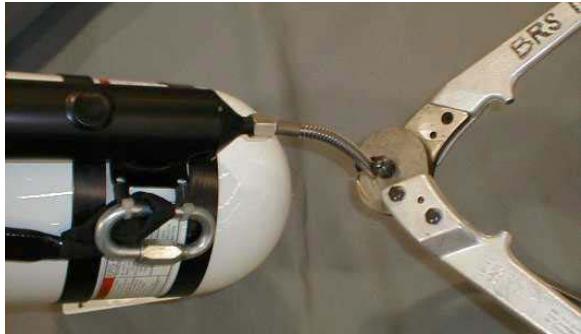
This photo shows the larger **Felco C16** cutter being used to sever one of the older style, stainless steel cable assemblies.

NOTE: DO NOT ATTEMPT TO CUT THE ACTIVATION HOUSING WITH AN ORDINARILY BOLT CUTTER OR SIDE CUTTER! They are **NOT** effective at cutting the cable housing. The Felco or Greenlee brand cutters gather the cable and work with surprising ease. They make a worthy addition to any rescue organization's standard tool box; being useful for cutting fences, steel cables, and other obstacles which may prevent workers from reaching the scene of an accident or freeing occupants.

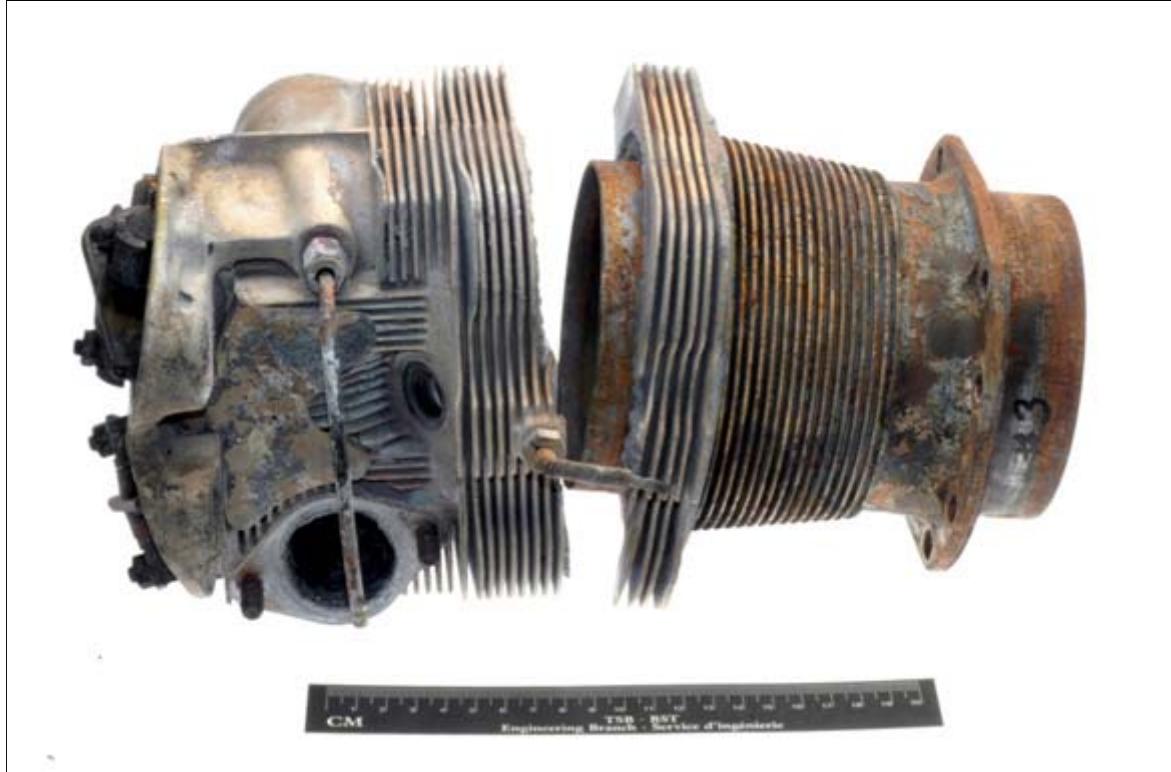
Figure 1. Le cylindre numéro 3 déposé du moteur

L'examen du moteur a révélé que la culasse du cylindre numéro 3 s'était détachée du barillet (voir la [figure 1](#)). La culasse est restée en place parce qu'elle était retenue par les circuits

d'admission et d'échappement. Aucune autre anomalie qui aurait pu empêcher le moteur de produire de la puissance n'a été découverte. L'examen de la culasse défectueuse du cylindre numéro 3 a révélé qu'elle s'était fracturée près des deuxième et troisième filets, et des criques de fatigue étaient visibles sur la surface de la fracture. Vue de l'extérieur, la fracture était située à la base des ailettes de refroidissement 4, 5 et 6³.
